KIMBALL (L ROBERT) AND ASSOCIATES EBENSBURG PA
NATIONAL DAM INSPECTION REPORT. LAKE ONDAGA DAM (NDI ID NUMBER --ETC(U)
APR 81 R J KIMBALL

PENNSYLVANIA
LAKE ONDAWA DAM

NDI ID NO. PA-517

6 National Dam Inspection Report

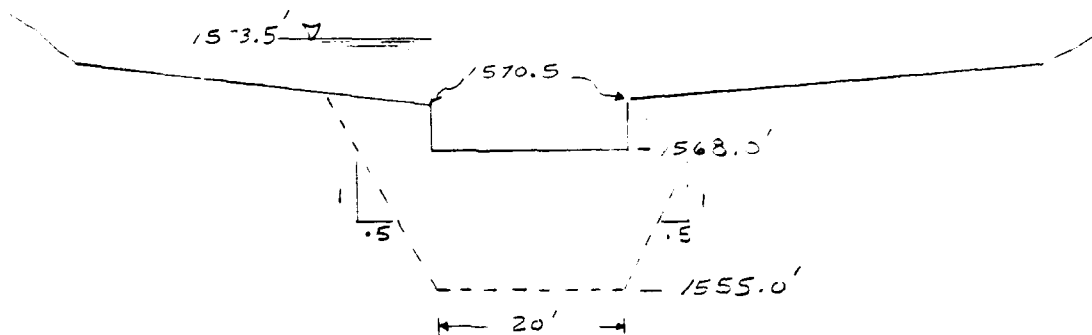
THE PMF ANALYSIS INDICATES THE DAM IS OVERTOPPED BY 3.45 FEET DURING THE 1/2 PMF. THE DEPTH OF OVERTOPPING AND DURATION IS CONSIDERED SUFFICIENT TO CAUSE FAILURE OF THE STRUCTURE.

BRWID = 20'
Z = 0.5
ELBM = 1555.0
TFAIL = 2HRS
WSEL = 1568.0
FAILEL = 1573.5

0.5 PMF UTILIZED
FOR BREACH ANALYSIS.
